# **Intel<sup>®</sup> Mobile (0.18μ) Celeron<sup>™</sup> Processor Specification Update**

Release Date: June 2000

Order Number: 245421-005

The Intel<sup>®</sup> Mobile (0.18μ) Celeron<sup>™</sup> processor may contain design defects or errors known as errata which may cause the product to deviate from published specifications. Current characterized errata are documented in this Specification Update.

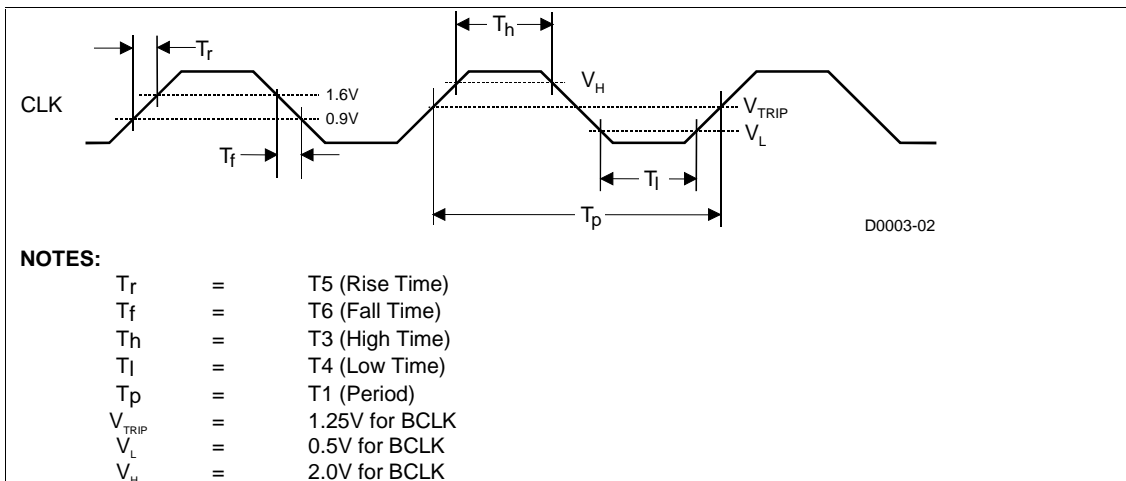
Figure 6. BCLK Timing Waveform

Symbol	Parameter	Min	Typ	Max	Unit	Figure	Notes
	System Bus Frequency		100		MHz		
T1	BCLK Period		10		ns	Figure 6	Note 2
T2	BCLK Period Stability			±250	ps		Notes 3, 4
T3	BCLK High Time	2.70			ns	Figure 6	at >2.0V
T4	BCLK Low Time	2.45			ns	Figure 6	at <0.5V
T5	BCLK Rise Time	0.175		0.875	ns	Figure 6	(0.9V – 1.6V)
T6	BCLK Fall Time	0.175		0.875	ns	Figure 6	(1.6V – 0.9V)

1. All AC timings for GTL+ and CMOS signals are referenced to the BCLK rising edge at 1.25V. All CMOS signals are referenced at 0.75V.
2. The BCLK period allows a +0.5 ns tolerance for clock driver variation.
3. Not 100% tested. Specified by design/characterization.
4. Measured on the rising edge of adjacent BCLKs at 1.25V. The jitter present must be accounted for as a component of BCLK skew between devices.

For B0 step processors, the  $V_{IH,BCLK}$  Min spec is changed to 2.0V (from 1.7V for A2 step) and  $V_{IL,BCLK}$  Max spec is changed to 0.5V (from 0.7V for A2 step). Due to this, new values are specified for BCLK high and low times for B0 step processors. These modifications affect corresponding specs in Table 12, Table 13, Table 22, and Figure 6 in *Mobile Celeron™ Processor in BGA2 and Micro-PGA2 Packages at 500 MHz, 450 MHz, and 400A MHz* datasheet.

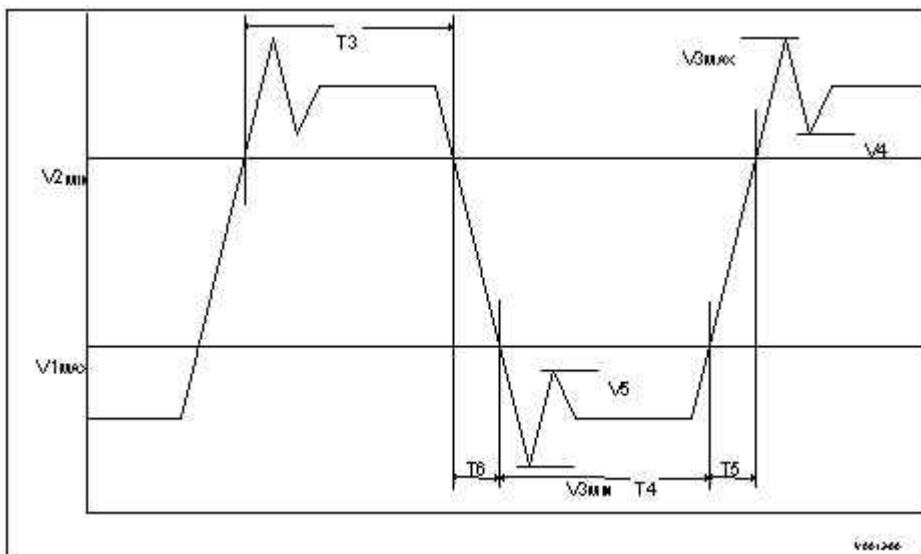
Figure 4. BCLK Waveform at the Processor Core Pins

In Table 18, “BCLK Signal Quality AC Specifications at the Processor Core” of the *Intel® Celeron™ Processor Mobile Module: Mobile Module Connector 2 (MMC-2) at 500 MHz and 450 MHz Datasheet*, Note 3 has changed. Figure 4 “BCLK Waveform at the Processor Core Pins” has also been updated. See below.

- The rising edge ringback voltage specified is the minimum absolute voltage that the BCLK signal can dip back to after the BCLK signal passes the  $V_{IH,BCLK,MIN}$  (rising) voltage limits. The falling edge ringback voltage specified is the maximum absolute voltage that the BCLK signal can dip back to after the BCLK signal passes the  $V_{IL,BCLK,MAX}$  (falling) voltage limits.
